### Property Inspection during tenancy

No.: 10/18/2012 000108 Date: 18/10/2012

Property Code	THE001
Property Address	2 The Street, Anywhere, Ireland
Tenants name(s)	Joe Blogs
Date Inspected	18/10/2012
Property alarmed	No
Property inspected by	Property manager

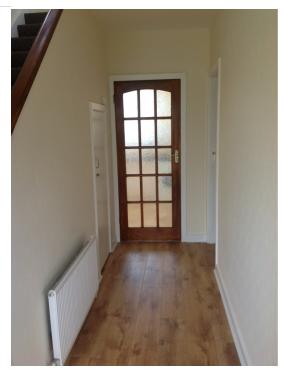
Flooring is in good condition, free from damage and is secure	Very good
The walls are clear of hooks, nails, holes and paint is in good condition	Very good
Ceiling is in good condition, free of stress cracks and water stains	Very good
Door(s), architraves and skirting are in good condition	Very good
Air vents are open/clear	No air vent
Any sign of mould or condensation	No
Door stop is secure and in proper location	No door stop
General condition of the room	Very good
Work required	
Entrance hallway photo 1

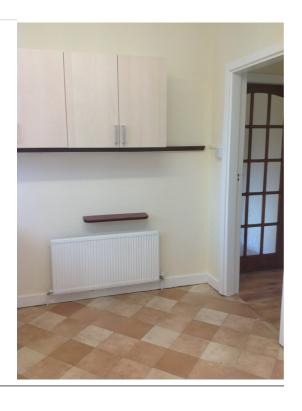
Kitchen photo 3

Door(s), architraves and skirting are in good condition	Very good
Air vents are open/clear	Yes
Any sign of mould or condensation	No
Window glass and handle are in good condition	Yes
Counters are in good condition	Yes
Seal where counter meets wall and sink are	Yes
clean and in good condition	
There are no leaks from handle(s) or around	Yes
base of the tap/taps	
Fire extinguisher	No
Fire blanket	No
General condition of the room	Very good
Work required	
Penlace fire extinguisher and fire blanket

Replace fire extinguisher and fire blanket Kitchen photo 1

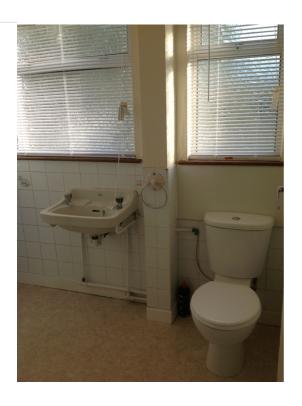
Window glass and handle are in good condition Extractor fan is functioning and is free of dust Counters are in good condition Seal where counter meets wall and sink are  handle broken Fan not working Not applicable Yes
Counters are in good condition  Seal where counter meets wall and sink are  Not applicable Yes
Seal where counter meets wall and sink are Yes
clean and in good condition
There are no leaks under the sink and the No leaks
ubend
There are no leaks from handle(s) or around Yes
base of the tap/taps
Shower screen/door/curtain and rail are in Good
good condition
Inspect bath/shower walls. Press tiles to check Very Good
for loose tiles and tiles are in good condition.
Seal is in good condition Yes
Toilet is free from leaks Yes
Toilet seat is in good condition and secure. Yes
Toilet is in good condition.
General condition of the room Very good
Work required

Repair window handle Repair extractor fan Bathroom photo 1

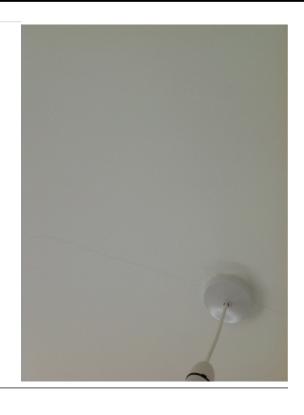
Bedroom 2 photo 3

Crack visible on ceiling. No work required. Bedroom 2 photo 1

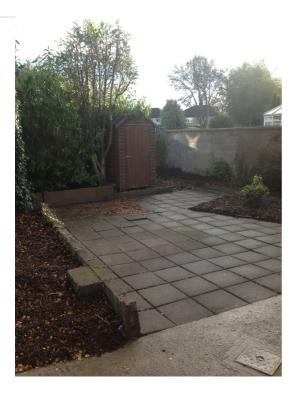
Windows	Good
Air vents are open/clear	Yes
Garden	See comments
General condition of the rear exterior	Very good
General comments	
Some paving slabs are uneven and may cause an accident Work required	
Level paving slabs Rear exterior photo 1

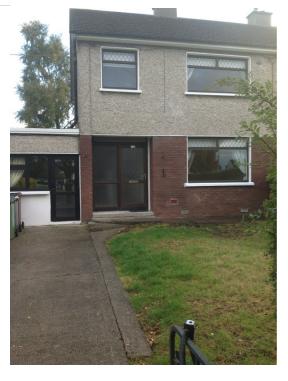
Front exterior photo 1

A tree has been cut from the garden and new grass seed planted.
